**USD #294 Oberlin Schools
Oberlin, KS**

District & Facility Assessment

December 16, 2022

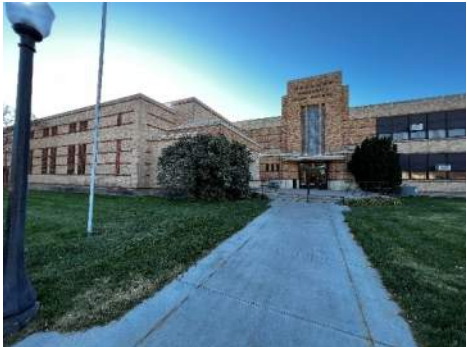
1.	Example of main entry with no accessible access point.

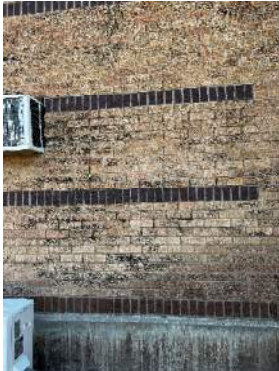
3.	Example of area that needs brick tuck pointing

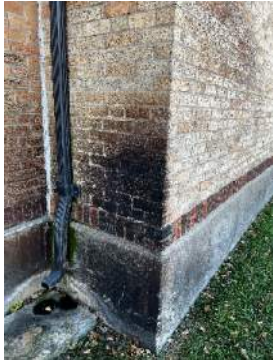
4.	Example of effervescence on the building.

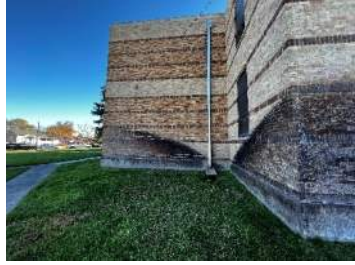
11.	Example of effervescence on the building.

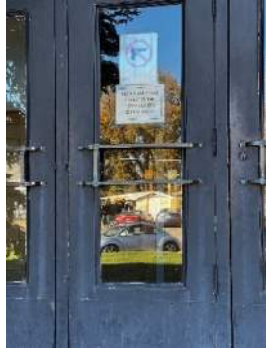
12.	Example of older door needing replacement

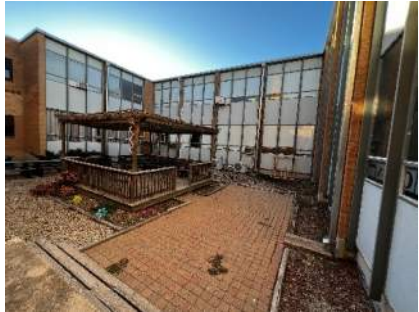
13.	Picture looking at courtyard with curtain wall from the 1966 addition needing replacement.

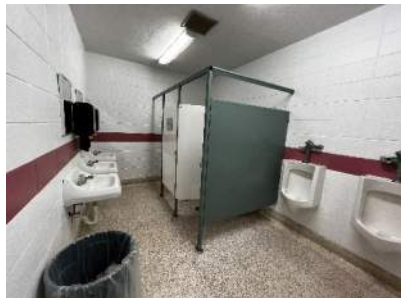
15.	1966 building restroom that does not meet ADA. One of many like this condition.

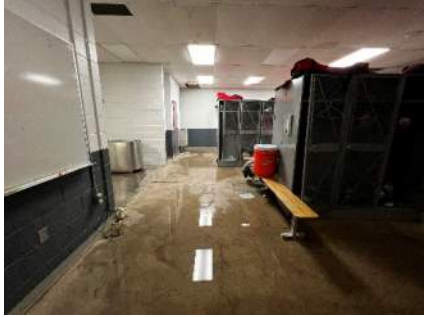
16.	Wrestling/Football locker room with no ADA showers, and currently water is on the floor from the exterior stairwell not draining properly.

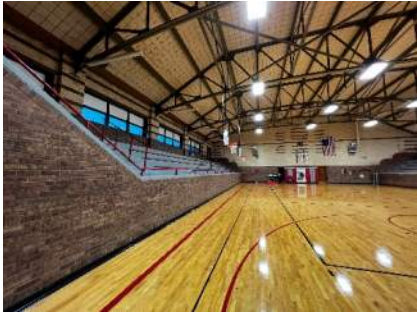
17.	1938 gymnasium with no place or access point for individuals in wheelchairs.

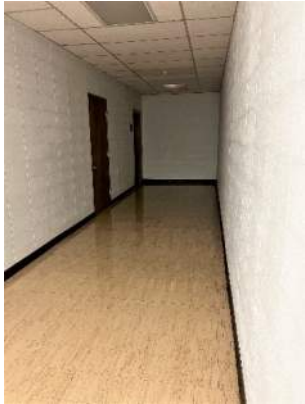
18.	Example of a dead-end corridor.

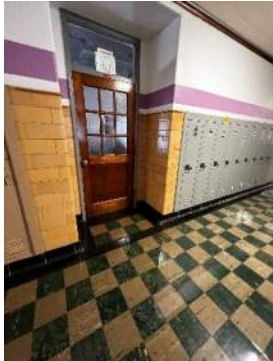
19.	Example of a classroom entry door. This doorway is typical throughout the building. The handle is a knob and not a lever and does not have adequate distance on the strike side of the door to meet ADA.

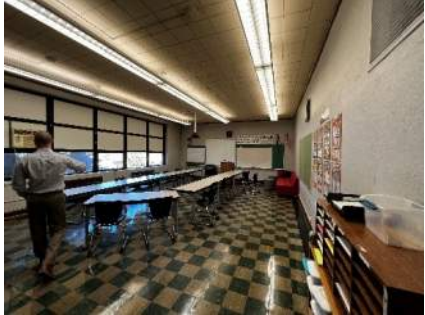
21.	Typical classroom in the 1938 building with original flooring, and no ceilings. Acoustics in these rooms are very bad and not conducive for teaching. In addition, the rooms in the portion of the building are undersized.

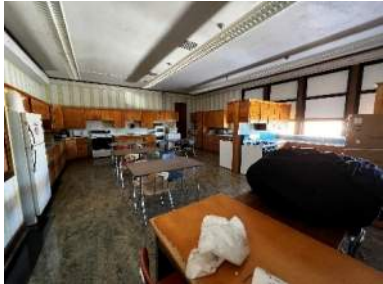
22.	Example of a room that code dictates must have two exits. This room has one. Another room like this is the band room.

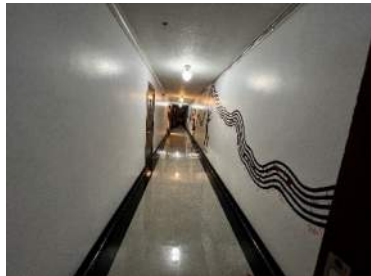
23.	Picture of the music hallway. The hallway is too narrow and cannot have doors that open this far into the hallway per code. Lack of adequate lighting creates a dark space.

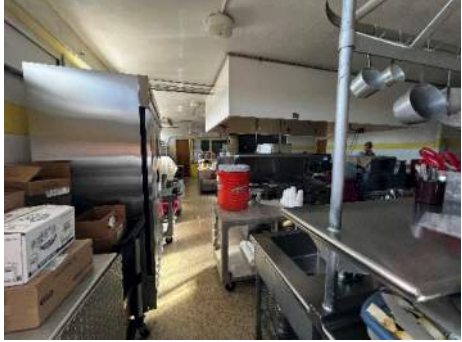
25.	Picture of the kitchen. The hood does not operate properly currently.

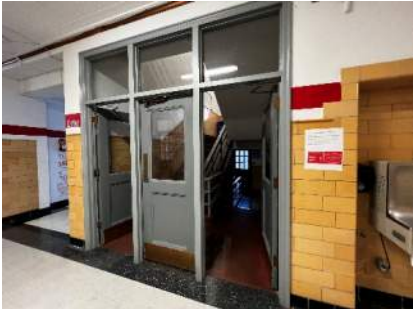
27.	Doors at bottom of exit stair swinging in wrong direction, this is a code violation.

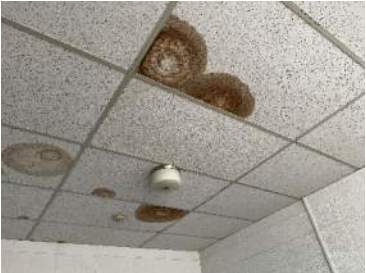
28.	Example of ceiling tile damaged from roof leaks

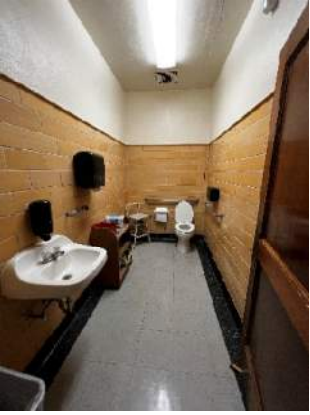
31.	Restroom of auditorium with major settling cracking occurring in wall and ceiling.

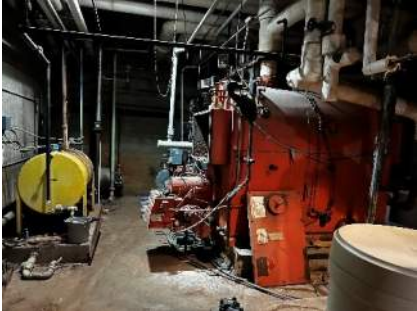
33.	Example of 1938 Boiler Room with abandoned boiler and original steam piping.

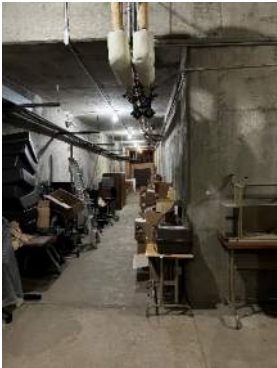
34.	Tunnel of 1966 addition that is storage and storm shelter location.

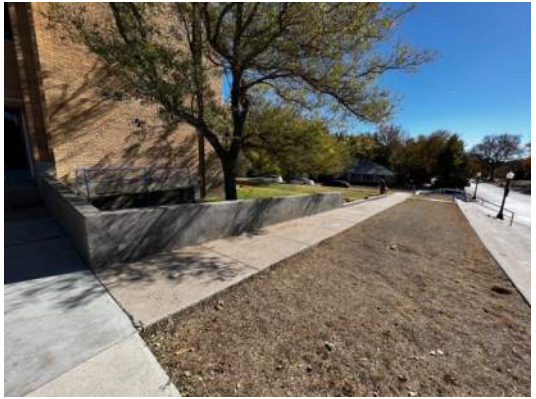
36.	There is some erosion visible where there is no grass to prevent this from occurring.

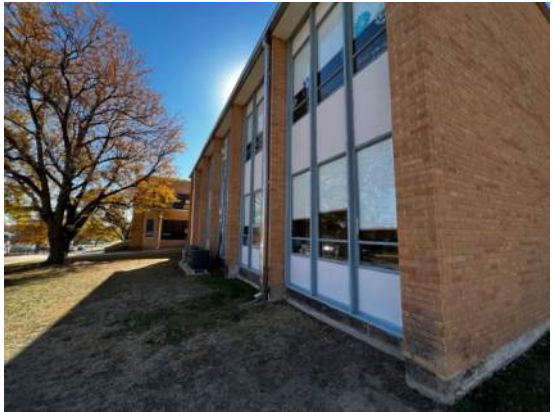
37.	There is some erosion visible where downspouts spill onto concrete splash blocks around the building at various locations.

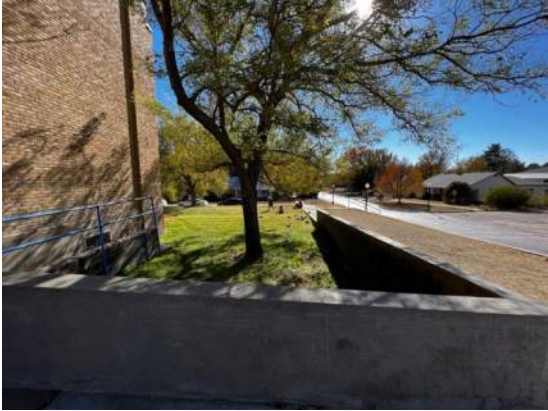
38.	The ground immediately around the building has sunken slightly, but enough in some areas to allow water to pond just outside of the building due to a heavy rain.

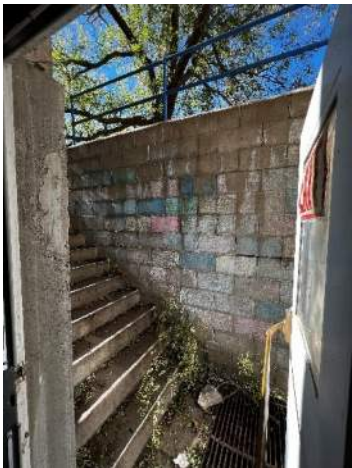
39.	Picture of exterior stair outside of basement art room. This stair is required as the second exit but has no handrails to meet code.

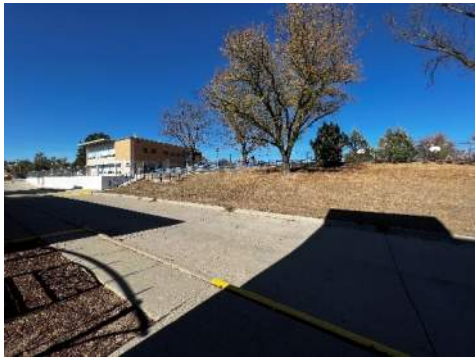
40.	Example of the long ADA ramp to get to the upper level of the kindergarten building.

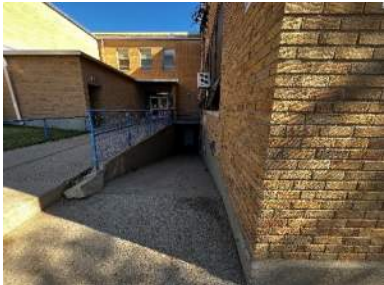
41.	One of only two accessible entrances off the West of the building. Currently this is the secure door to get buzzed into the school for visitors.

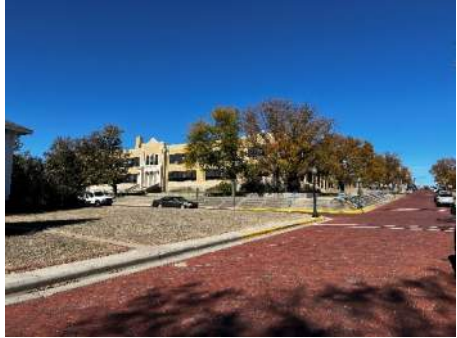
42.	Beautiful front of building. However it is very difficult to distinguish what door is the main door to the building. In addition, like mentioned earlier no ADA access.

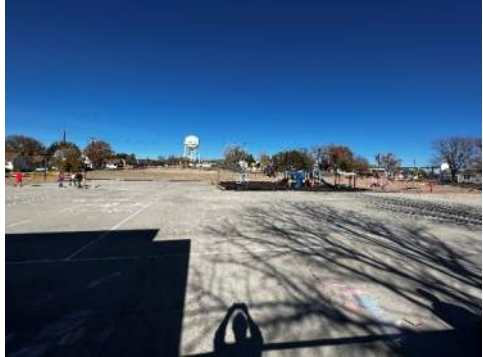
43.	Playground looking North. Sloping causes drainage issues and flooding.

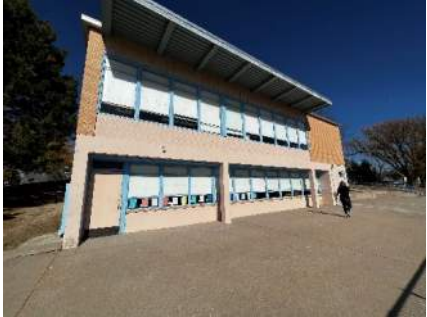
44.	Kindergarten Building South Face, all windows need replaced as they are well beyond their life cycle and are single pane glass.

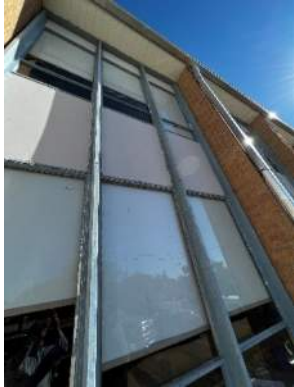
45.	1965 Building Curtainwall glass wall system with single pane glass.

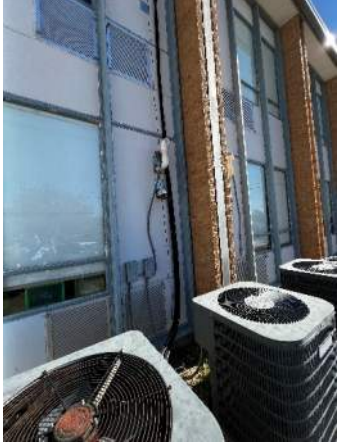
46.	Example of refrigerant piping and flues installed on the exterior of the building.

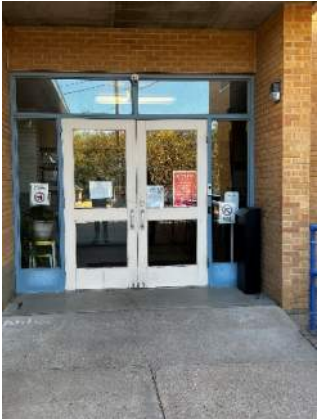
47.	Example of wood entry doors that are beyond life cycle.

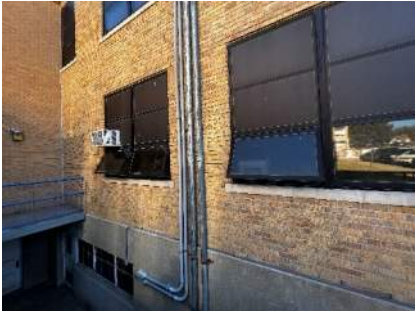
48.	Example of 1926 building replaced windows with window air conditioners.

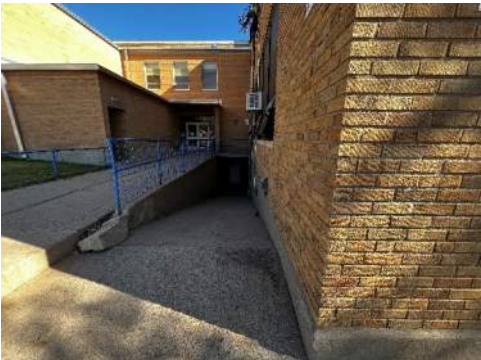
49.	Exterior ramp on West side that is access to boiler room.

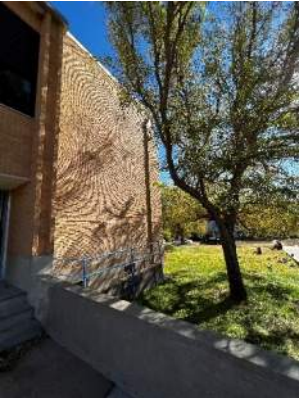
50.	Photo of exterior stairwell out of basement art room. There is no sidewalk per code to the public sidewalk.

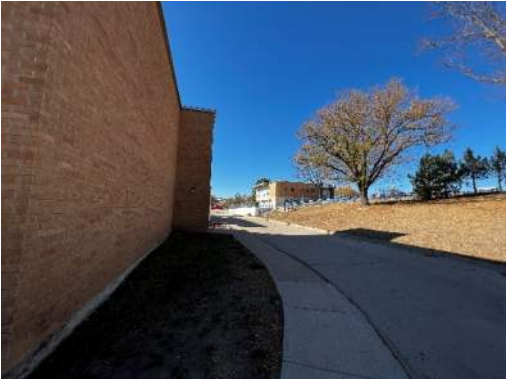
51.	Picture of service drive on North of building that separates the main building from the Kindergarten Building.

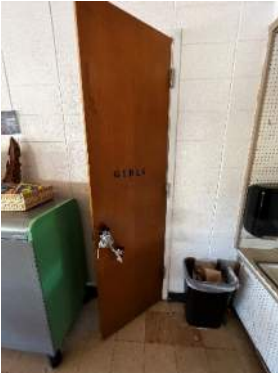
52.	Some of the doors throughout the build have not had the doorknob change to a lever to meet ADA requirements.

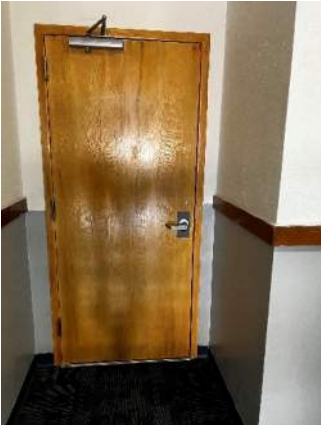
53.	Example of door that does not meet ADA for side approach clearances

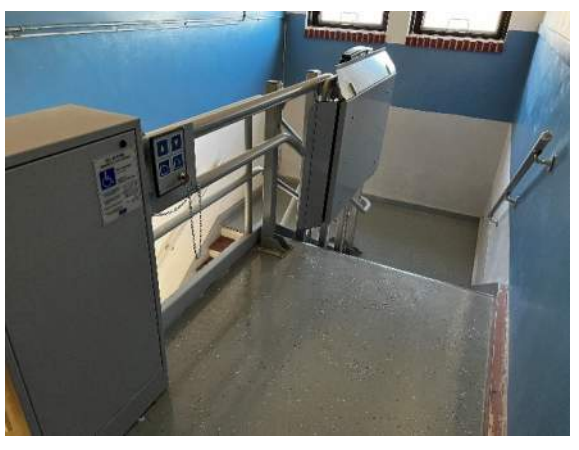
54.	<p>The building is multi story and stairs are the main way to circulate from one level to another. There is at one location in the building a wheelchair lift that is designed to follow the stairs. If the lift is in use, it does not allow for anyone to use the stair until it is stored, causing a fire hazard.</p>

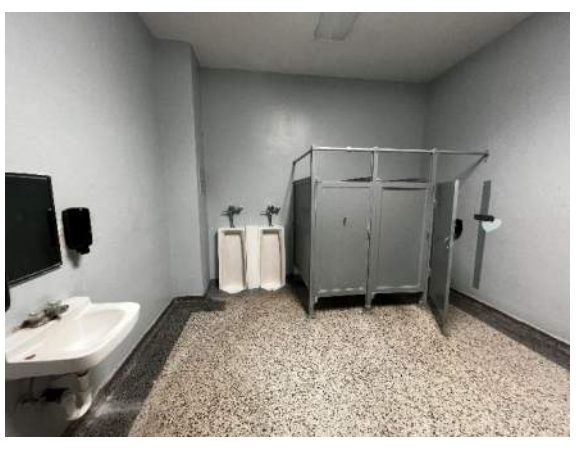
55.	<p>The restrooms throughout the building do not provide the clearance required to meet current ADA standards.</p>

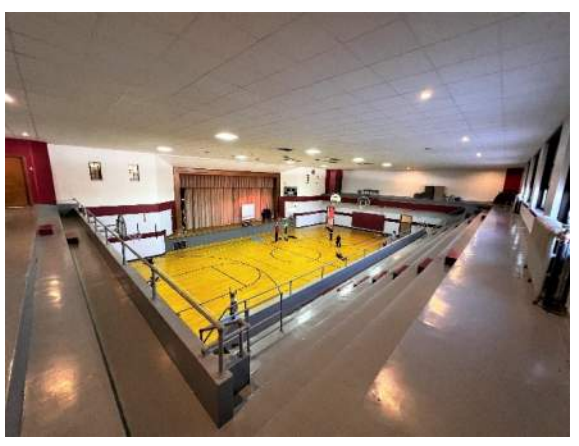
56.	<p>Upper level of gym. Note the guard rail along the end of the court provides a safety concern due to its height. The height is acceptable for sitting and viewing, however if someone is horsing around it is low enough that they could easily fall to the floor below.</p>

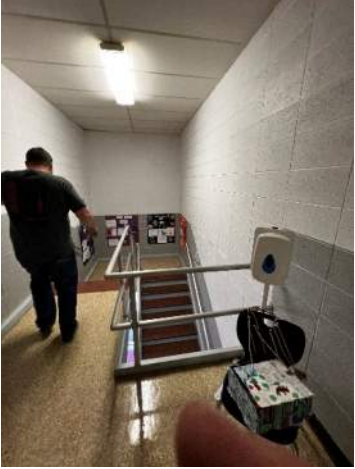
57.	Stairwell with too short of guardrail per code.

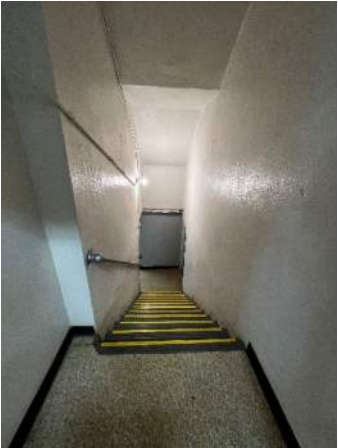
59.	Stairwell to basement art room. Incorrect handrail configuration.

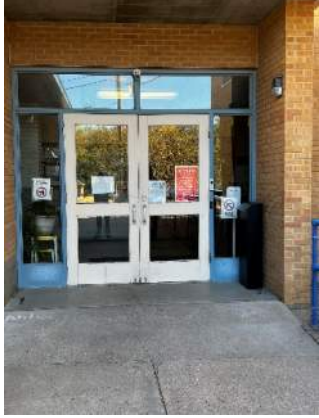
60.	Main access-controlled entry. Once you enter this door the office is down and around the corner allowing visitors complete access to building.

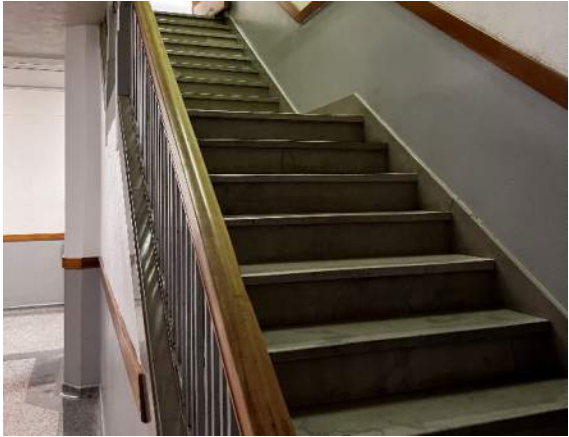
61.	East stair next to gym looking up from main level. Note that handrails are not present to meet current code.

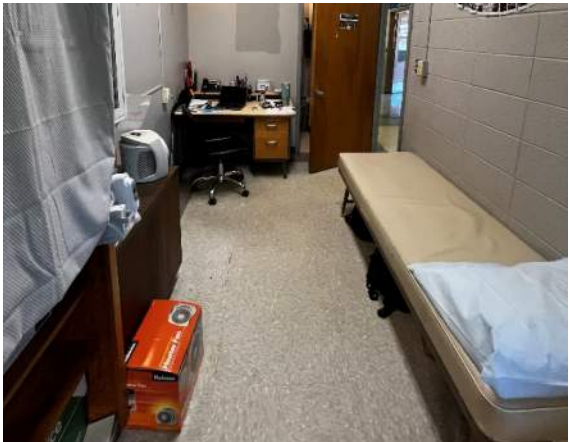
62.	Student Health looking South. Note that due to its size there is only room for 1 sick child at a time. This room is located off the main office which does allow for office staff to oversee if the Nurse is out. Also, behind the door to the room is the door to the toilet which because of the location of the desk makes access not compliant with ADA requirements.

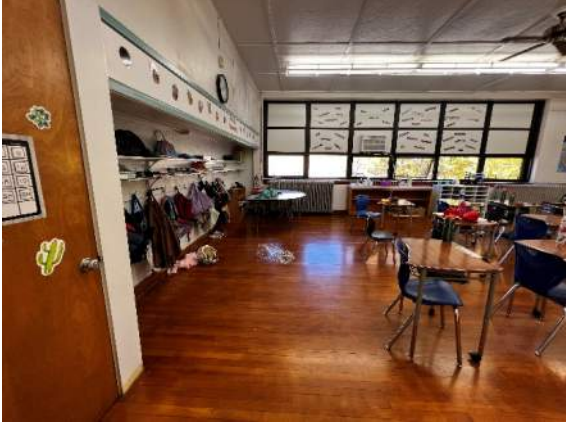
63.	Example of wood floor in 1923 classrooms. Floor is noisy.

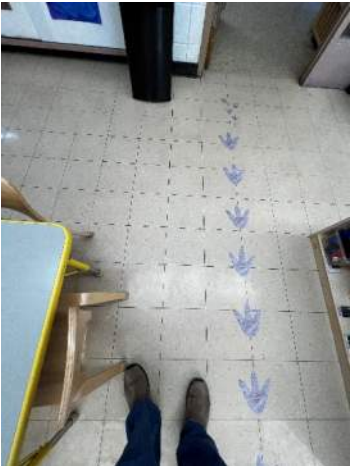
64.	Example of Vinyl Asbestos Flooring that is prevalent in the 1965 addition.

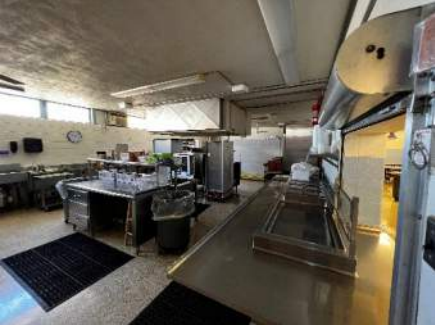
65.	Kitchen has outdated equipment, and inadequate heating and cooling.

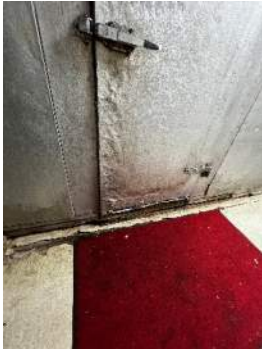
66.	Walk-in cooler and freezer are in need of replacement.

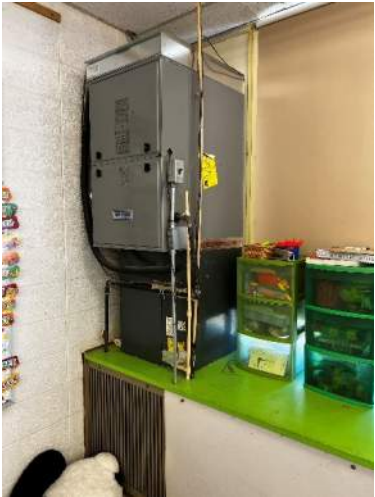
67.	Example of HVAC equipment exposed in classrooms. These systems were retrofitted into the existing cabinets.

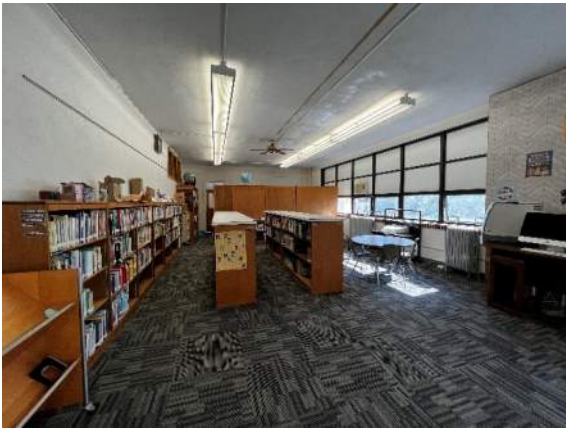
68.	Library: This is an example of exterior wall radiators for heat and window air conditioning for cooling.

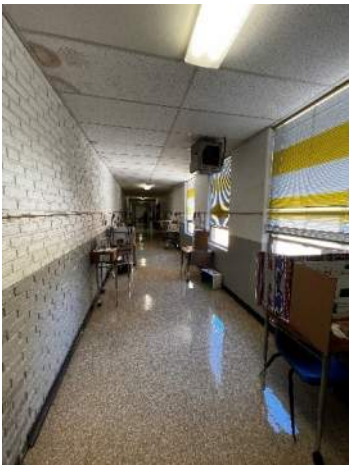
69.	Interior hallway that currently has no working heat.
