**USD #294 Oberlin Schools
Oberlin, KS**

District & Facility Assessment

December 16, 2022

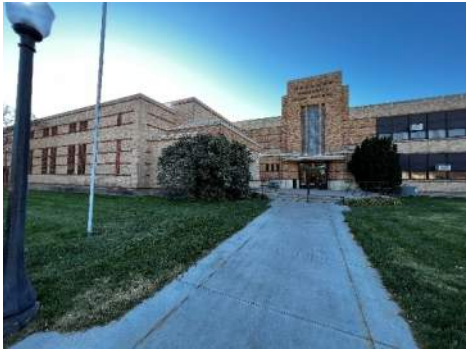
| <p>1.</p> | <p>Example of main entry with no accessible access point.</p> | |

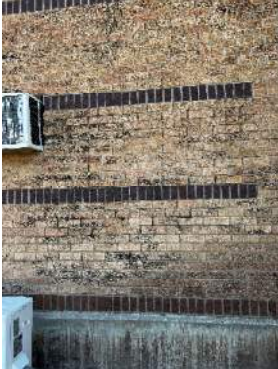
| <p>3.</p> | <p>Example of area that needs brick tuck pointing</p> | |

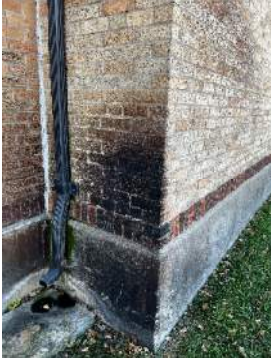
| <p>4.</p> | <p>Example of effervescence on the building.</p> | |

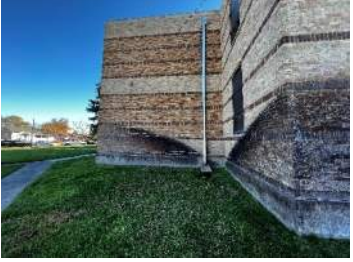
| <p>11.</p> | <p>Example of effervescence on the building.</p> | |

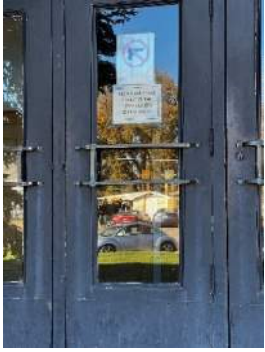
| <p>12.</p> | <p>Example of older door needing replacement</p> | |

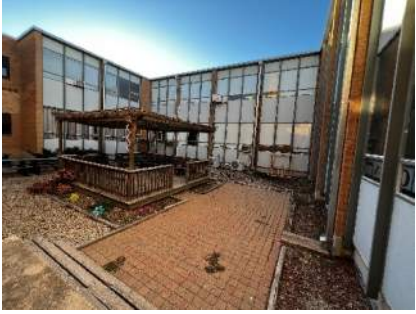
| <p>13.</p> | <p>Picture looking at courtyard with curtain wall from the 1966 addition needing replacement.</p> | |

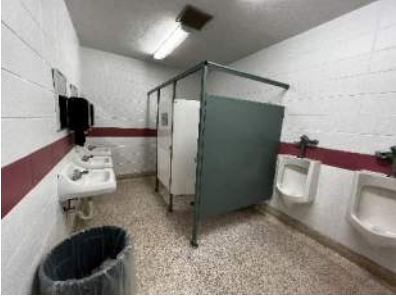
| <p>15.</p> | <p>1966 building restroom that does not meet ADA. One of many like this condition.</p> | |

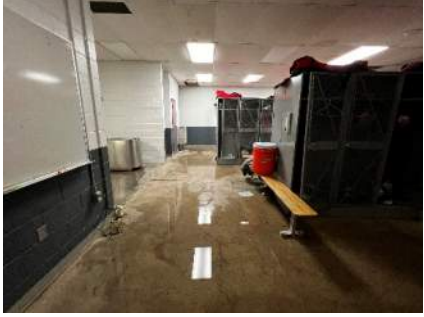
| <p>16.</p> | <p>Wrestling/Football locker room with no ADA showers, and currently water is on the floor from the exterior stairwell not draing properly.</p> | |

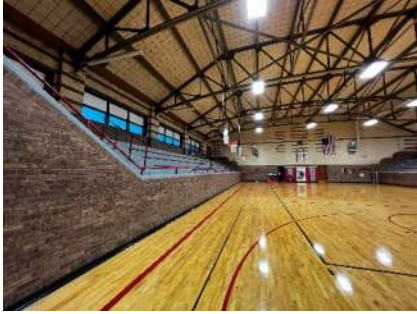
| <p>17.</p> | <p>1938 gymnasium with no place or access point for individuals in wheelchairs.</p> | |

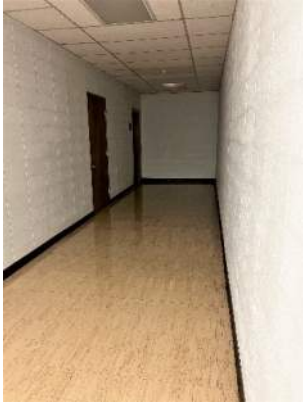
| <p>18.</p> | <p>Example of a dead-end hallway</p> | |

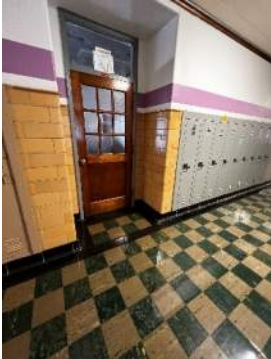
| <p>19.</p> | <p>Example of a classroom entry door. This doorway is typical throughout the building. The handle is a knob and not a lever and does not have adequate distance on the strike side of the door to meet ADA.</p> | |

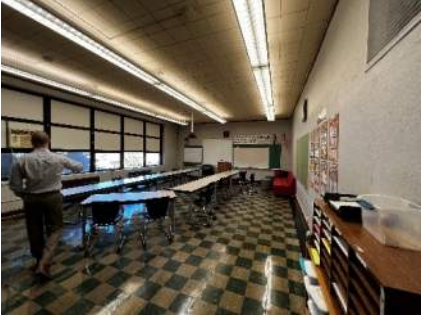
| <p>21.</p> | <p>Typical classroom in the 1938 building with original flooring, and no ceilings. Acoustics in these rooms are very bad and not conducive for teaching. In addition the rooms in the portion of the building are undersized.</p> | |

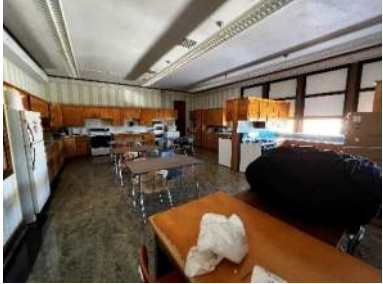
| <p>22.</p> | <p>Example of a room that code dictates have two exits. This room has one. Another room like this is the band room.</p> | |

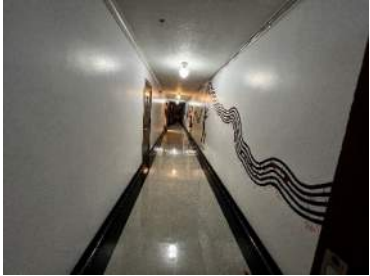
| <p>23.</p> | <p>Picture of the music hallway. Hallway is too narrow and cannot have doors that open this far into the hallway per code.</p> | |

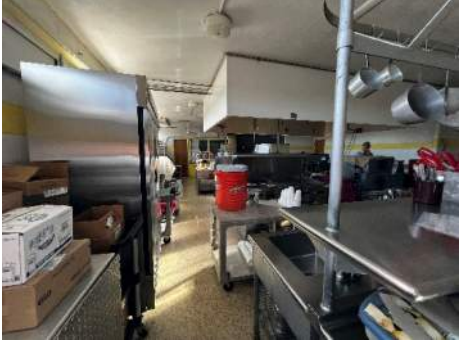
| <p>25.</p> | <p>Picture of the kitchen. The hood does not operate properly currently.</p> | |

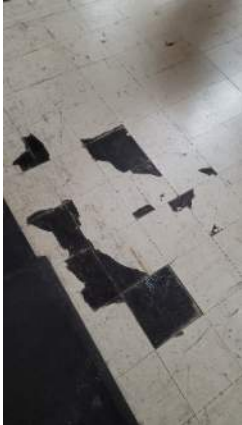
| <p>26.</p> | <p>Broken asbestos floor tile in the weight room. This tile can become dangerous if it is ground into a dust that can be inhaled.</p> | |

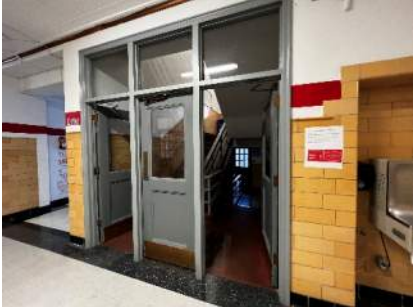
| <p>27.</p> | <p>Doors at bottom of exit stair swinging in wrong direction, this is a code violation.</p> | |

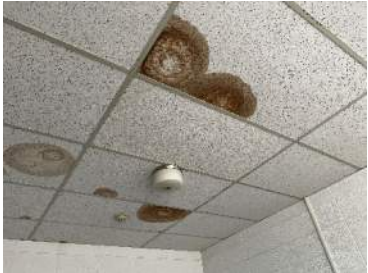
| <p>28.</p> | <p>Example of ceiling tile damaged from roof leaks</p> | |

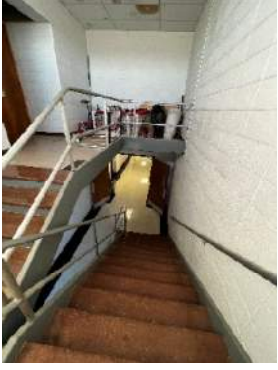
| <p>29.</p> | <p>Stairwell with non code compliant handrails and no guardrails.</p> | |

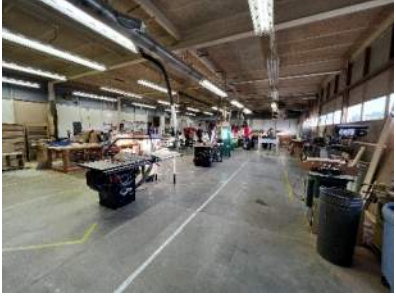
| <p>30.</p> | <p>Wood shop with limited heat. Some unit heaters don't work at all.</p> | |

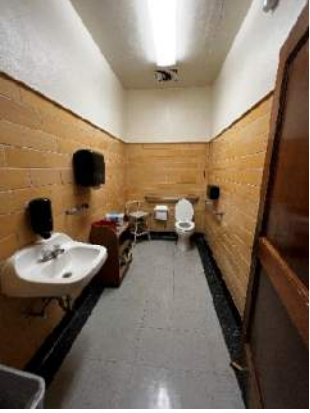
| <p>31.</p> | <p>Restroom of auditorium with major settling cracking occurring in wall and ceiling.</p> | |

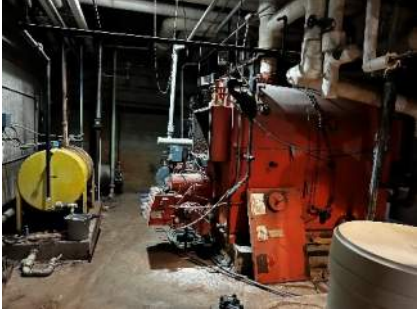
| <p>33.</p> | <p>Example of 1938 Boiler Room with abandoned boiler and original steam piping.</p> | |

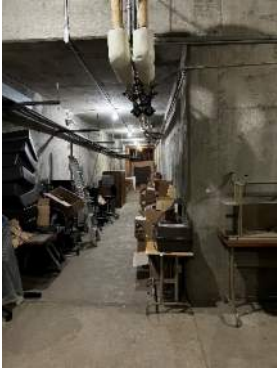
| <p>34.</p> | <p>Tunnel of 1966 addition that is storage and storm shelter location.</p> | |

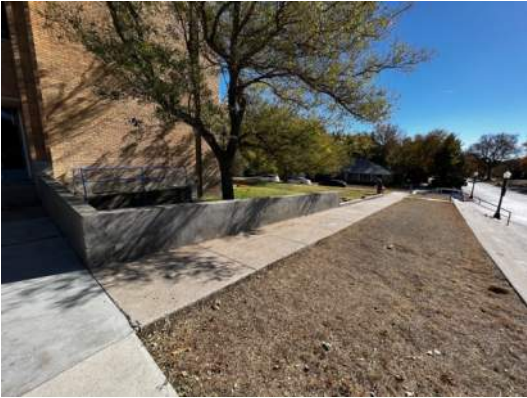
| <p>36.</p> | <p>There is some erosion visible where there is not grass to prevent this from occurring.</p> | |

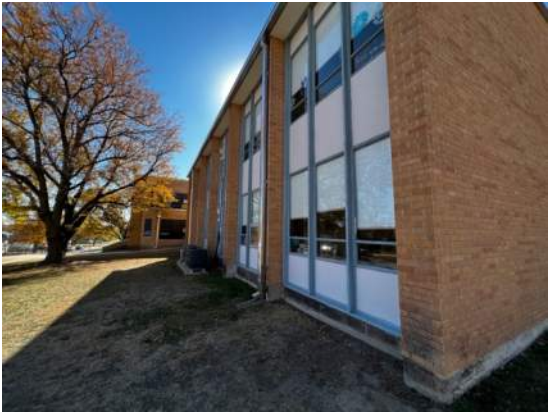
| <p>37.</p> | <p>There is some erosion visible where downspouts spill onto concrete splash blocks around the building at various locations.</p> | |

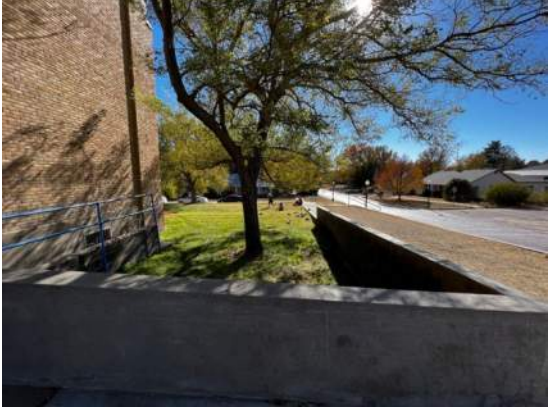
| <p>38.</p> | <p>The ground immediately around the building has sunken slightly, but enough in some areas to allow water to pond just outside of the building due to a heavy rain.</p> | |

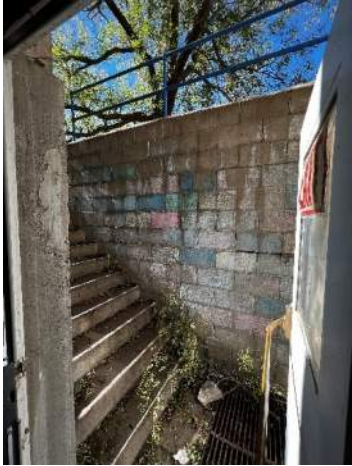
| <p>39.</p> | <p>Picture of exterior stair out of basement art room. This stair is required as the second exit but has no handrails to meet code.</p> | |

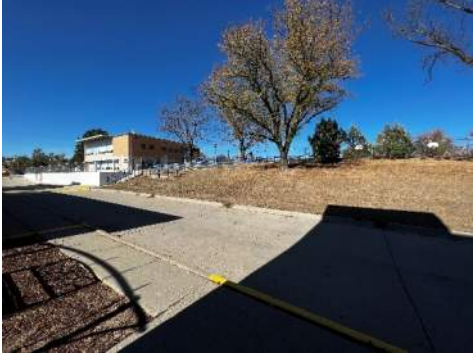
| <p>40.</p> | <p>Example of the long ADA ramp to get to the upper level of the kindergarten building.</p> | |

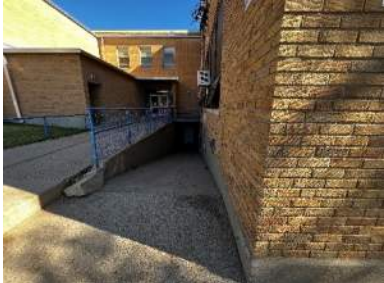
| <p>41.</p> | <p>One of only two accessible entrances off the West of the building. Currently this is the secure door to get buzzed into the school for visitors.</p> | |

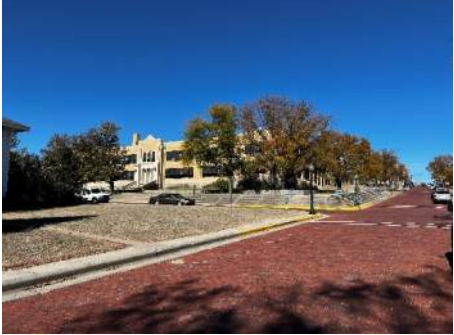
| <p>42.</p> | <p>Beautiful front of building. However very difficult to distinguish what door is the main door to the building. In addition, like mentioned earlier no ADA access.</p> | |

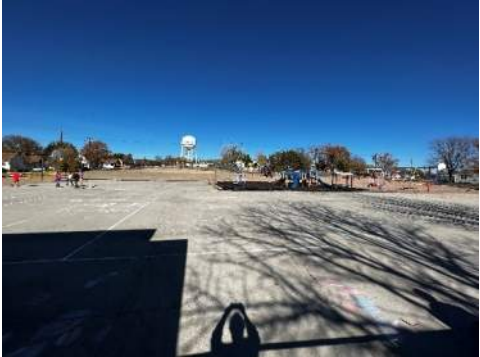
| <p>43.</p> | <p>Playground looking North. Sloping causes drainage issues and flooding.</p> | |

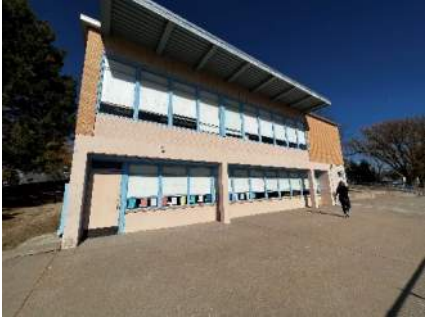
| <p>44.</p> | <p>Kindergarten Building South Face, all windows need replaced as they are well beyond their life cycle and are single pane glass.</p> | |

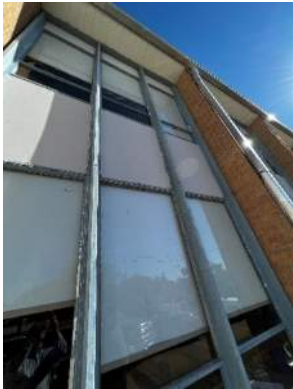
| <p>45.</p> | <p>1965 Building Curtainwall glass wall system with single pane glass.</p> | |

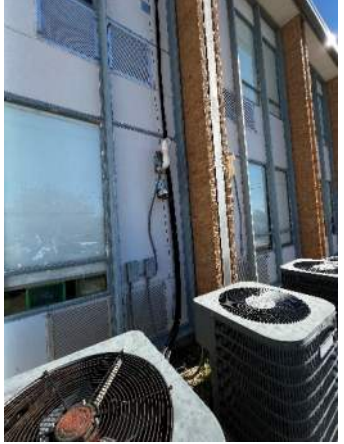
| <p>46.</p> | <p>Example of refrigerant piping and flues installed on the exterior of the building.</p> | |

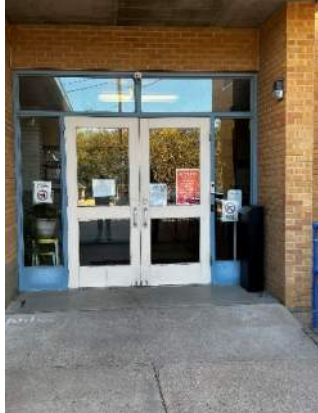
| <p>47.</p> | <p>Example of wood entry doors that are beyond life cycle.</p> | |

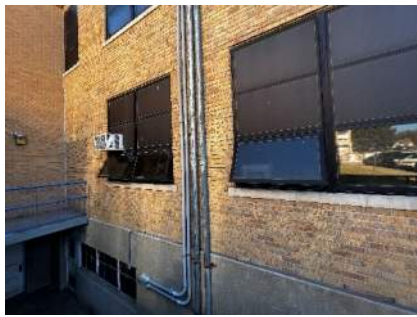
| <p>48.</p> | <p>Example of 1926 building replaced windows with window air conditioners.</p> | |

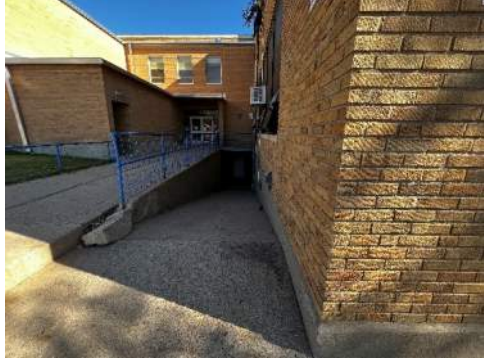
| <p>49.</p> | <p>Exterior ramp on West side that is access to boiler room.</p> | |

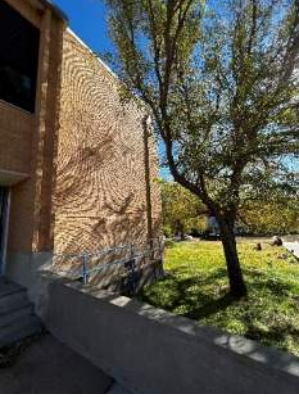
| <p>50.</p> | <p>Photo of exterior stairwell out of basement art room. There is no sidewalk per code to the public sidewalk.</p> | |

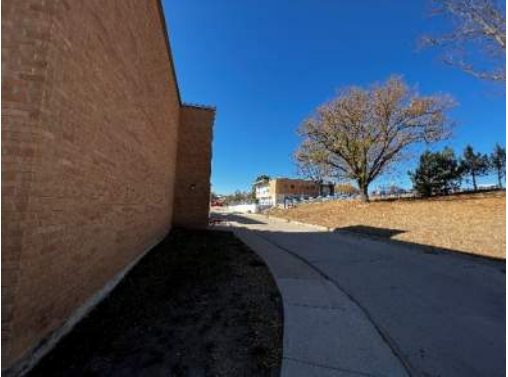
| <p>51.</p> | <p>Picture of service drive on North of building that separates the main building from the Kindergarten Building.</p> | |

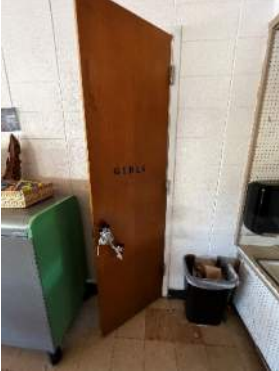
| <p>52.</p> | <p>Some of the doors throughout the build have not had the door knob change to a lever to meet ADA requirements.</p> | |

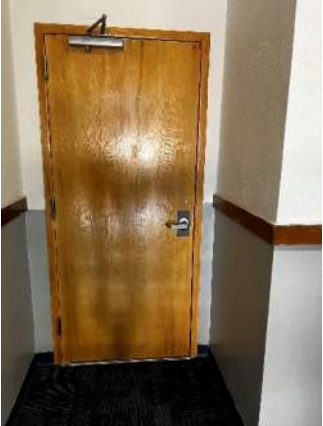
| <p>53.</p> | <p>Example of door that does not meet ADA for side approach clearances</p> | |

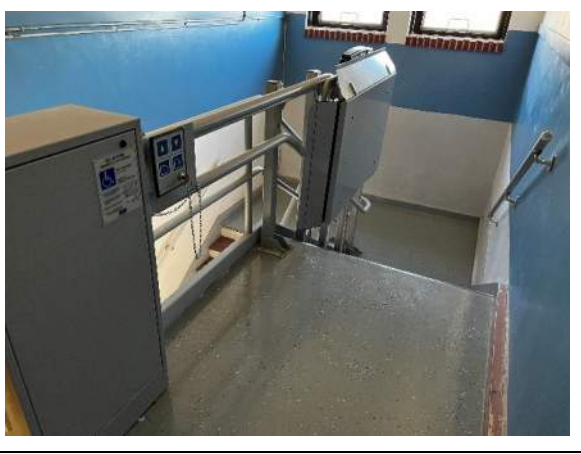
| <p>54.</p> | <p>The building is multi story and stairs are the main way to circulate from one level to another. There is at one location in the building a wheelchair lift that is designed to follow the stairs. If the lift is in use it does not allow for anyone to use the stair until it is stored, causing a fire hazard.</p> | |

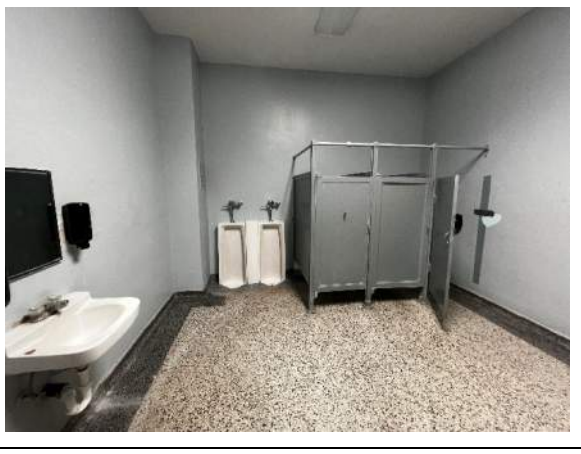
| <p>55.</p> | <p>The restrooms throughout the building do not provide the clearance required to meet current ADA standards.</p> | |

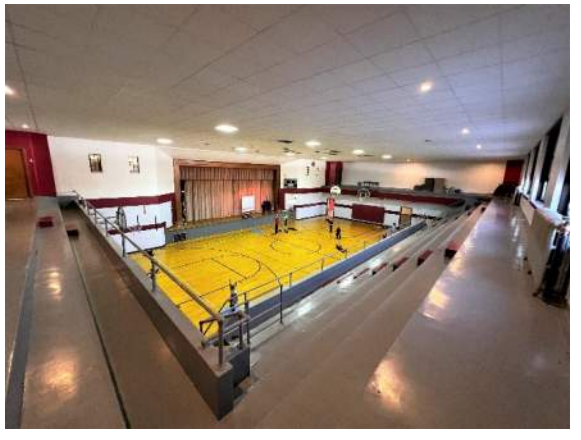
| <p>56.</p> | <p>Upper level of gym. Note guard rail along the end of the court provides a safety concern due to its height. The height is acceptable for sitting and viewing, however if someone is horsing around it is low enough that they could easily fall to the floor below.</p> | |

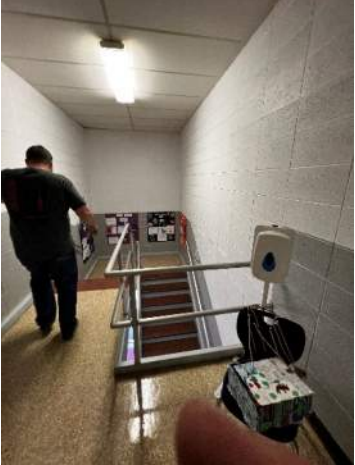
| <p>57.</p> | <p>Stairwell with too short of guardrail per code.</p> | |

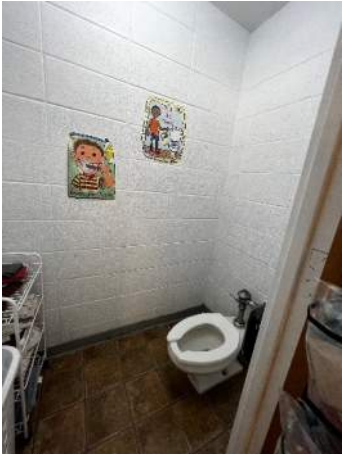
| <p>58.</p> | <p>Example of classroom toilet that is too small and does not meet ADA. Also, these toilets and piping are freezing during cold periods.</p> | |

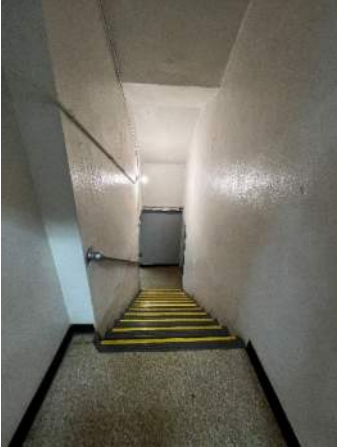
| <p>59.</p> | <p>Stairwell to basement art room. Incorrect handrail configuration.</p> | |

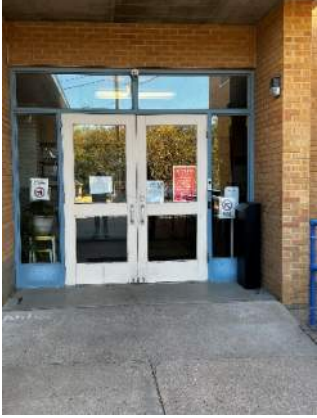
| <p>60.</p> | <p>Main access-controlled entry. Once you enter this door the office is down and around the corner allowing visitors complete access to building.</p> | |

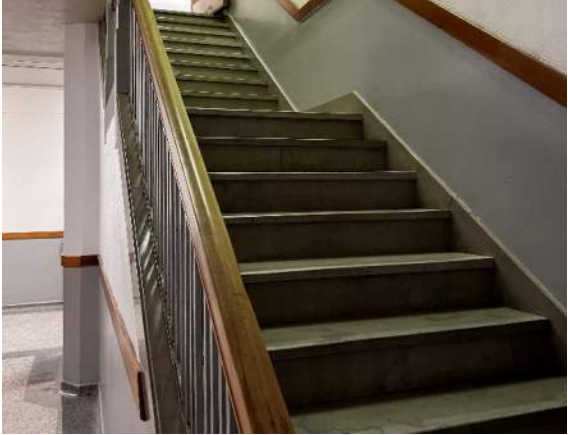
| <p>61.</p> | <p>East stair next to gym looking up from main level. Note that handrails are not present to meet current code.</p> | |

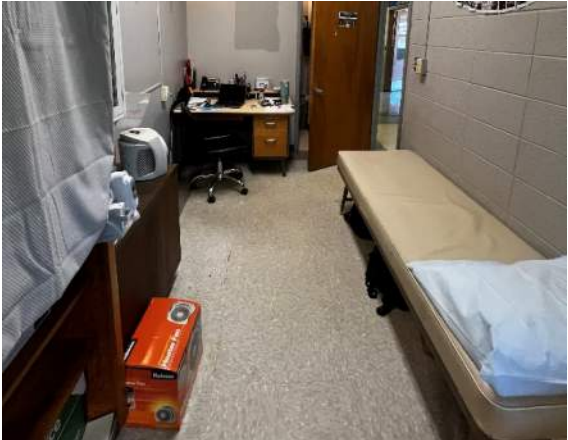
| <p>62.</p> | <p>Student Health looking South. Note that due to its size there is only room for 1 sick child at a time. This room is located off the main office which does allow for office staff to oversee if Nurse is out. Also, behind the door to the room is the door to the toilet which because of the location of the desk makes access not compliant with ADA requirements.</p> | |

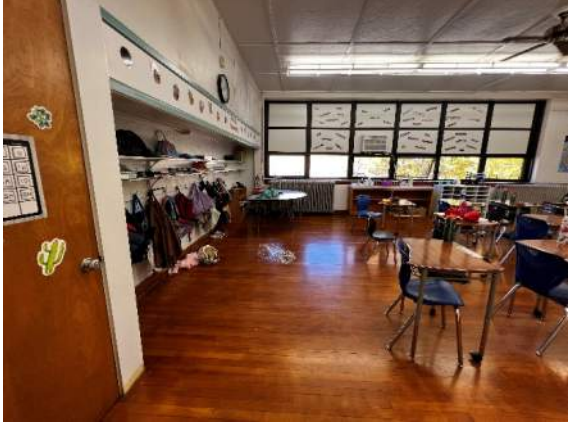
| <p>63.</p> | <p>Example of wood floor in 1923 classrooms. Floor is noisy.</p> | |

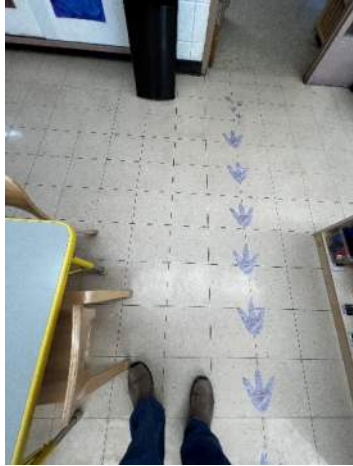
| <p>64.</p> | <p>Example of Vinyl Asbestos Flooring that is prevalent in the 1965 addition.</p> | |

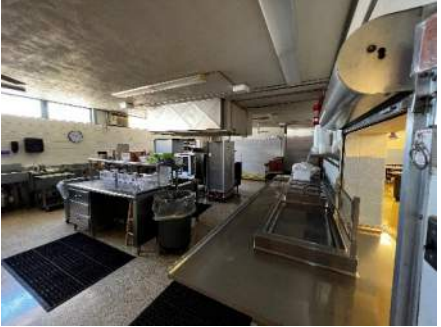
| <p>65.</p> | <p>Kitchen has outdated equipment, and inadequate heating can cooling.</p> | |

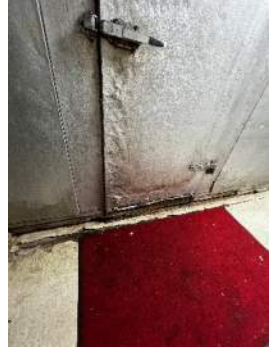
| <p>66.</p> | <p>Walk-in cooler and freezer are in need of replacement.</p> | |

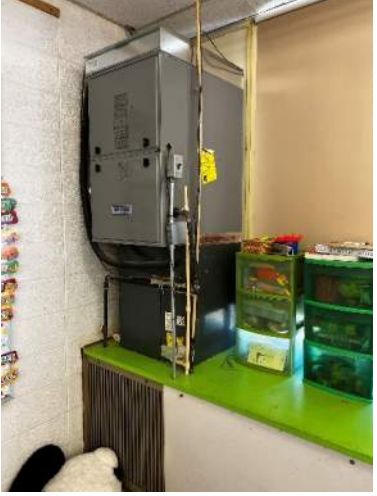
| <p>67.</p> | <p>Example of HVAC equipment exposed in classrooms. These systems were retrofitted into the existing cabinets.</p> | |

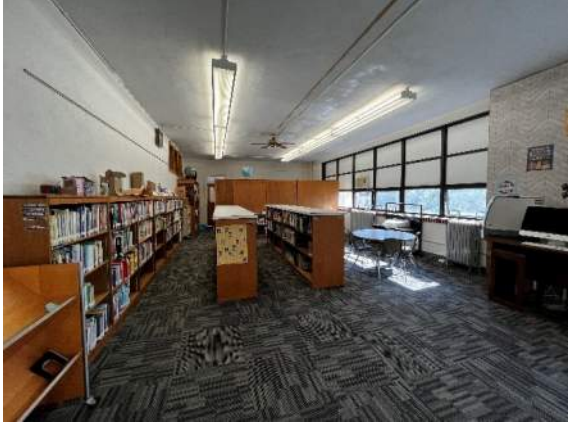
| <p>68.</p> | <p>Library: This is an example of exterior wall radiators for heat and window air conditioning for cooling.</p> | |

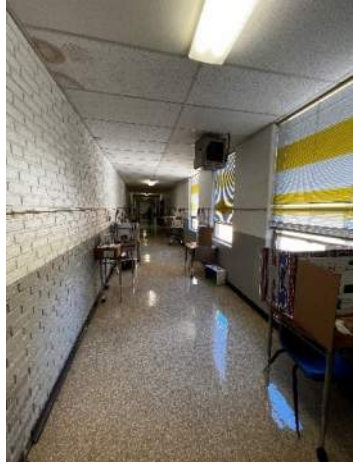
| <p>69.</p> | <p>Interior hallway that currently has no working heat.</p> | |
